Ecological Assessment of Henderson Creek

Prepared for

Waitakere City Council

February 2000

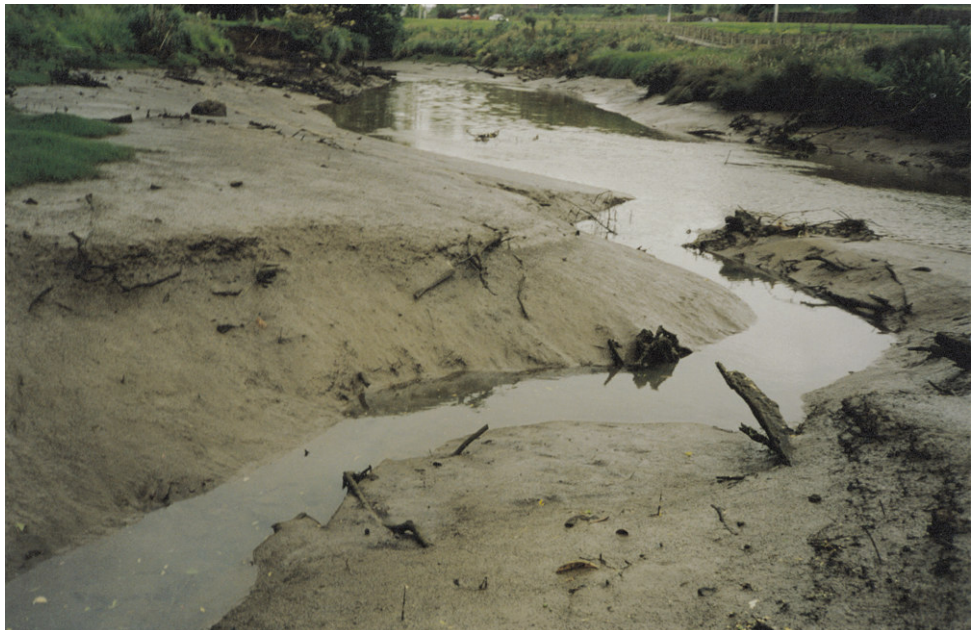
Fig. 3.1: Stormwater outfall site (located adjacent to Priority Restoration Site A).
